CONSIDERATIONS ON REHABILITATION OF IRRIGATION SPRINKLER PLOTS AND OF THE PUMPING STATIONS

Alexandru-Lucian LUCA¹, Mihail LUCA², Oana-Ștefania JUNCANARU², Gelu ILIE²

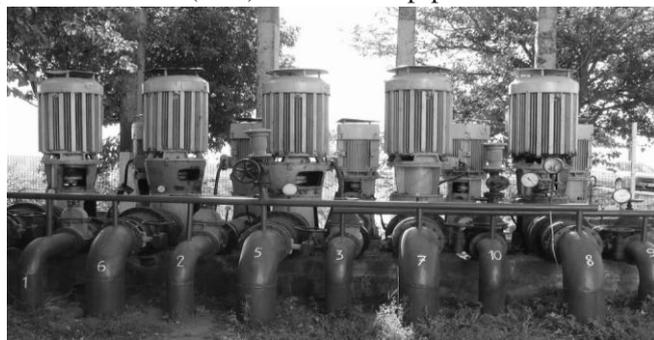
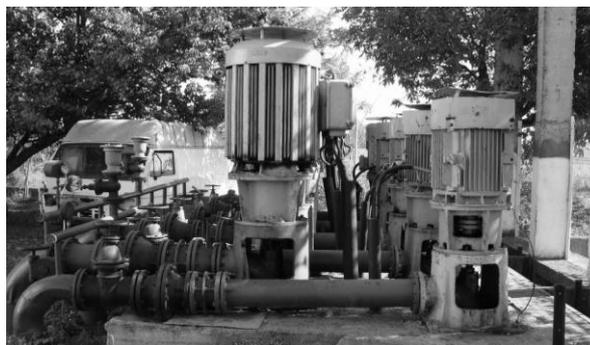
Figure 1 The hydromechanics line to old SPP1b: a - front view; b - side view, highlighting the two pressure stages.

PPS1b station pressurizing of the irrigation system Soloneț-North is a classic presentation (figure 1). Irrigation plot serves an area of 1428 ha. Pressurizing station was designed in 1980, made in 1980-1983 and commissioned in 1983. The pumping station was designed with two pressure stages, to serve two methods of watering (figure 1):

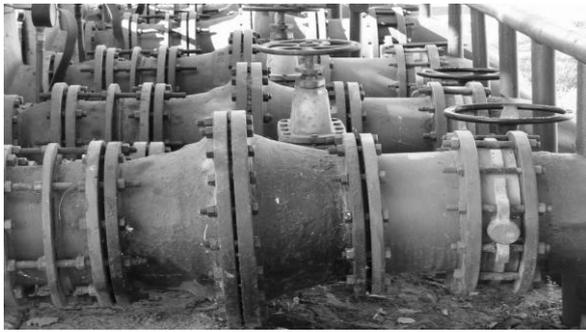
Figure 2 Details on the status of the pumping station SPP1b components: a - taps and check valves on the discharge line; b - hydrophor installation.

- hydraulic installation of the pumping station is worn, outdated operating periods (valves, dampers) and outdated; pipes are worn out and causes loss of water with high pressure pumping (*figure 2 a*);

3. Replacing the hydraulic pumping station (pipes, valves, check valves, fittings, etc.). The valves will allow for automation processes in the pumping station.

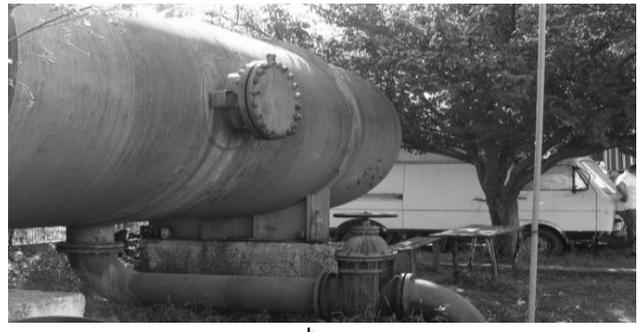
b

- hydraulic installation of shock protection system is fully degraded (*figure 2 b*);

4. Rehabilitation of the plant protection hydraulic shocks the structural and functional components. The installations of the pumping station adapting to process automation.

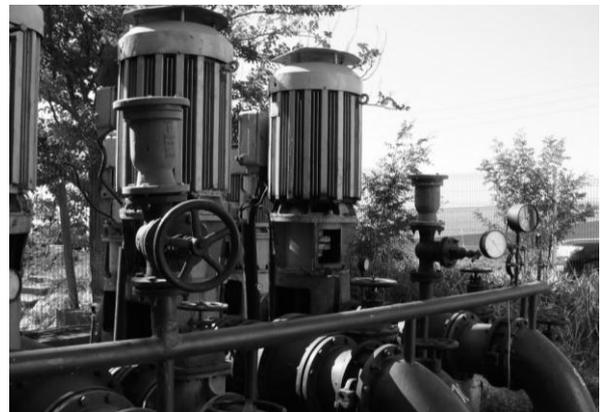
- monitoring installation of the operational parameters is partially degraded;

Figure 2 Details on the status of the monitoring installation

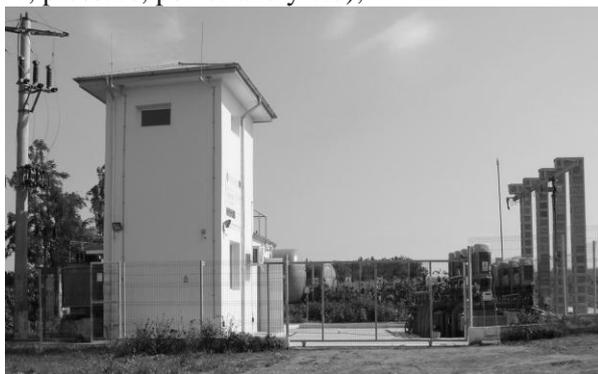
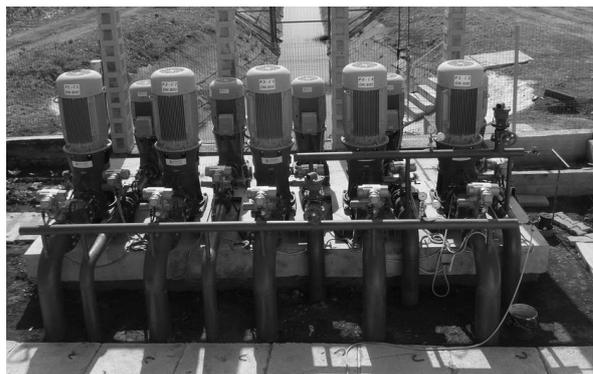
Figure 4 The pumping station SPP1b rehabilitated: a - general view; b – hydraulic installation.

All sequences rehabilitation process must be carried out fully to achieve the correct operation of the pumping station. SPP1b pumping station was rehabilitated in compliance with the above requirements. In the first stage construction was rehabilitated suction chamber, mud box and access area. In the second stage were selected pumping aggregates and were mounted on a reinforced concrete resized. In the third stage they were rehabilitated other facilities serving pumping station.

PPS 1b Solonet–North station was equipped with variable speed pumps. Pumping station was commissioned in 2016 (figure 3).

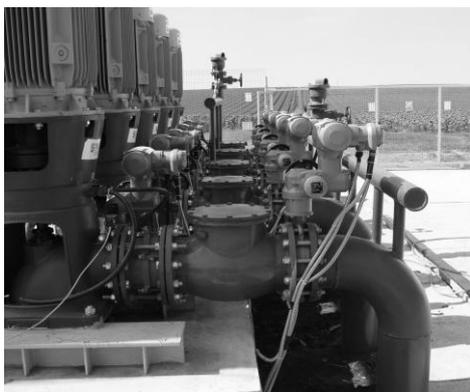
Figure 5 The rehabilitated hydraulic installation of the pumping station SPP1b
