CONSIDERATIONS ON REHABILITATION OF MONOPHILAR PUMPING STATIONS OF THE IRRIGATION SPRINKLER PLOTS

Abstract

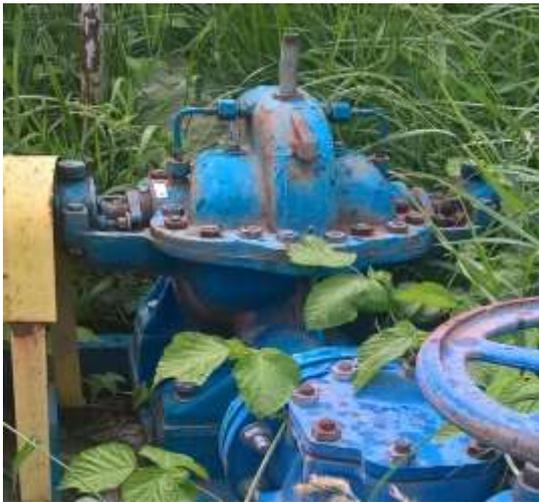
Figure 1 RDN 200-150-200 pump from Doniceasa - Fălcu Plot 7 SPPM (Photo Luca M., 2016)

The case study was prepared for Doniceasa - Fălcu Plot 7 from the Complex Irrigation and Drainage Unit Albița-Fălcu, Vaslui County. The irrigation plot provides aspersion watering for an area of 1222 ha. Water pumping and pressure raising is achieved with SPPMs located on the edge of the secondary supply canal CS82. SPPMs are equipped with 6NDS horizontal pumping units (some have been replaced with RDN pumps)

(figure 1). SPPM supplies one or two tertiary irrigation pipes (main laterals), in which case they are equipped with one or two pumping units. The pumps take the water from the supply canal and each one pumps it into the two pipes located perpendicular on both sides of the canal. Doniceasa - Fălcu Plot 7 is supplied from Prut River through the SRP4 Berezeni reversible pumping station and the CP5 supply canal.

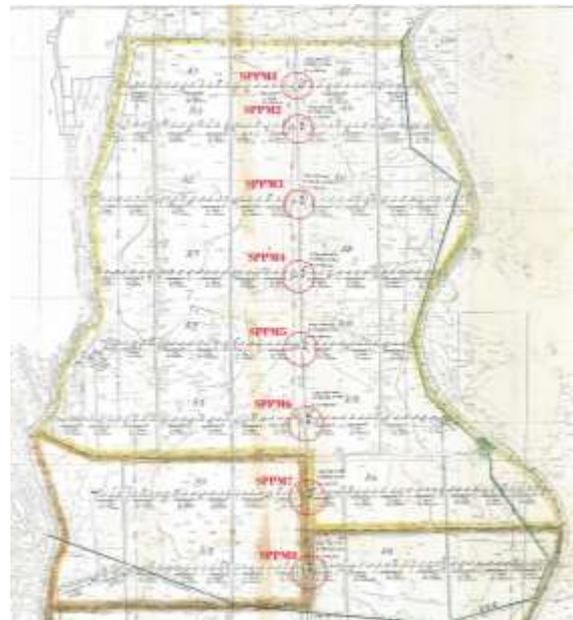
Figure 2 Doniceasa-Fălcui Plot 7 site plan (original version) (Luca M., 2016)

Plot 7 surface is 1222 ha. The plot is supplied with irrigation water from the CS82 canal, which is connected to the CA5 canal. The canal supplies 15 6NDS/RDN type electropumps ($Q = 270$ m³/h, $H = 70$ m, $n = 3000$ rpm, $P = 110$ kW) located in 8 single-line pumping and pressurising stations (figure 2).

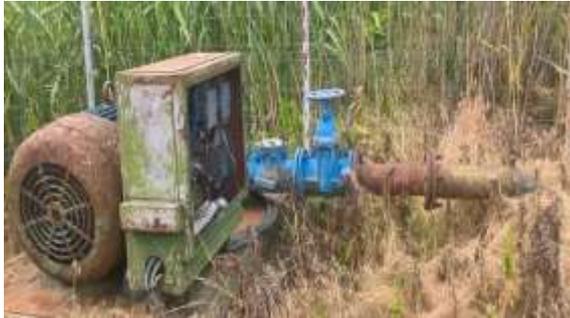
Figure 3 View of 7/5-2 pumping unit (6NDS), electric panel and discharge pipe of the SPPM 7/5 (Photo Luca M., 2016)

- The pumping units are manufactured during 1975-1980 and have an exceeded service period (figure 3, 4). The rehabilitation of some SPPMs was done by replacing the pump and the electric motor. Only the hydraulic connection of the pumping station to the single-line pipes is the original one.

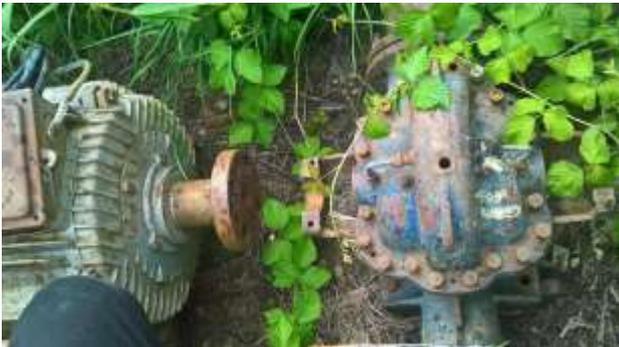
Figure 4 SPPM 7/7-2 pump aggregates status (RDN 200-150-200 pump and motor) (Photo Luca M., 2016)

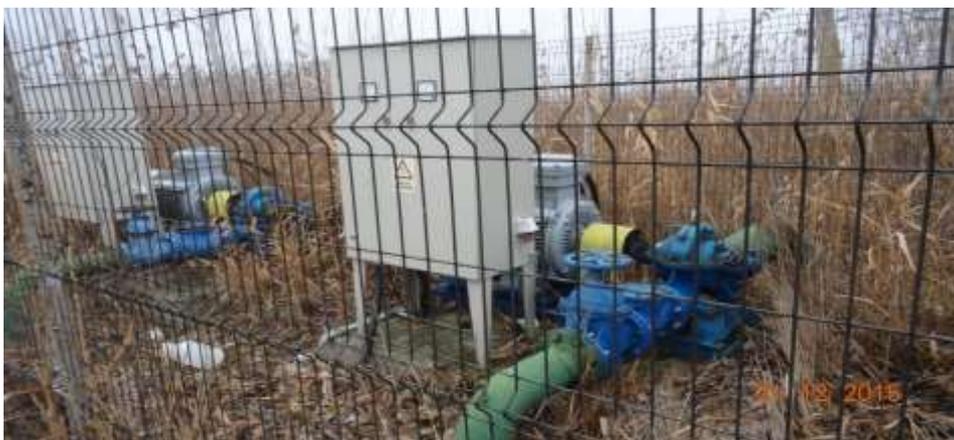
Figure 5 **General view of Doniceasa-Fălcu Plot 7 SPPM SP 7/2, partially rehabilitated (replacement of electric motor and electric panel)** (photo Luca M., 2016)

- The structural and functional state of the hydraulic installation in the pumping stations made of steel and cast iron (suction and discharge pipes, fittings, valves) is inadequate, being degraded in proportion of 60-85%.
- The horizontal pumping units, including those which have been rehabilitated (replacement of the pump and / or the electric motor), do not have primer

installations (figure 5, 6). The operational simulation of the single-line pumping station with modified pump parameters after 38 years in service showed an increase in energy consumption by about 32-41% compared to the initial state at the time it was put into service (Luca M., 2015).

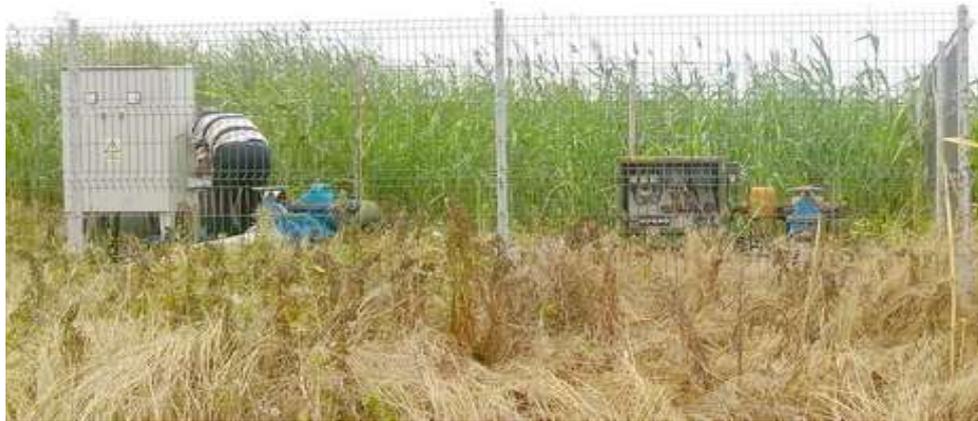
Figure 6 **General view of Doniceasa-Fălcu Plot 7 SPPM 7/5 partially rehabilitated (replacement of an electric motor and the electric panel for the pumping unit 7/5-1)** (Photo Luca M., 2016)
